SITE LOCATION: 1815 Cortlandt Street**AGENDA ITEM: II.f****HISTORIC DISTRICT:** Houston Heights East**HPO File No. 140202****Owner:** Reed Q. Kelly**Applicant:** Jeremy McFarland, Brickmoon Design**Date Application Accepted:** 1/29/2014**90-day Waiver:** N/A**SITE INFORMATION:**

TYPE OF APPROVAL REQUESTED: Relocation of a Contributing residence

CERTIFICATE OF APPROPRIATENESS

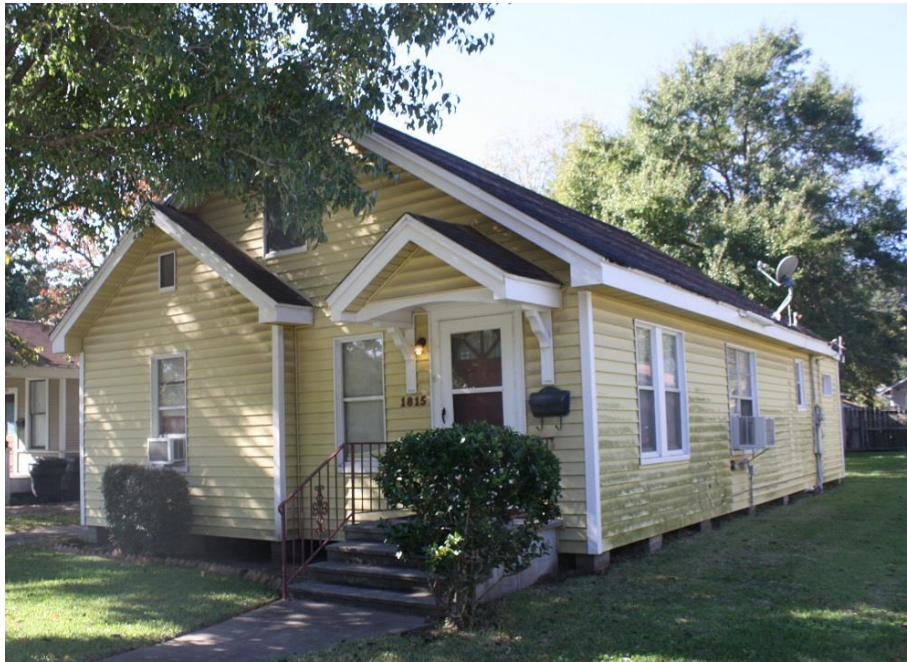
Current Photograph

The structure subject to the relocation is a one-story wood-frame single-family residence. The residence features a gable roof; a 1' projecting gabled bay on the north side of the front façade; and a 4'x6' applied porch roof on the south side of the front facade. The original square footage of the residence was 949 square feet. At the rear of the structure is a 50 square foot addition, and 200 square feet of the attic has been converted into living space.

The classification at the time of the inventory was 'potentially contributing' due to the residence having vinyl siding and aluminum windows. These alterations are considered reversible when historic housing stock is being inventoried for district designation. The house is otherwise in near-to-original configuration. The original massing, front façade features, and fenestration size and location details are intact.

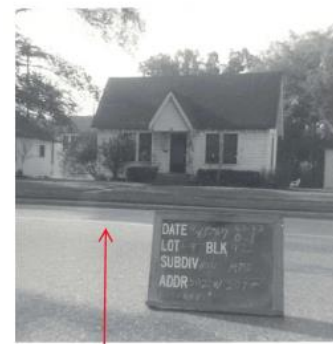
The largest and the first of the 2 - 5 room homes built with permit #4159

Unadjusted value and matches 1943 value. This represents first home built which has the most square footage.

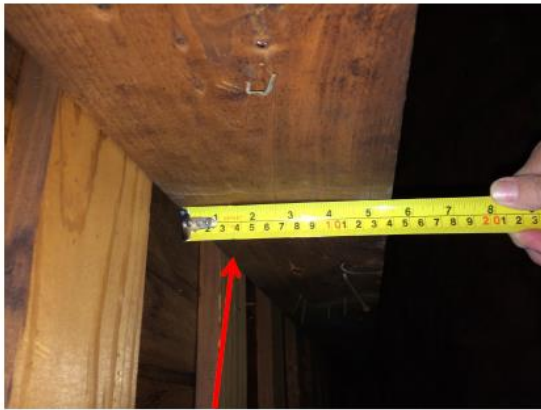
Materials used for construction of the residence are typical of modern nominal lumber sizes rather than historical dimensional lumber.

Roof Rafter 5 ½" nominal

Typical for lumber in historic buildings according to the lumber standards established in the mid 1920's is as noted in the boxes below: Our house does not meet these standards. Therefore lacks historical significance.

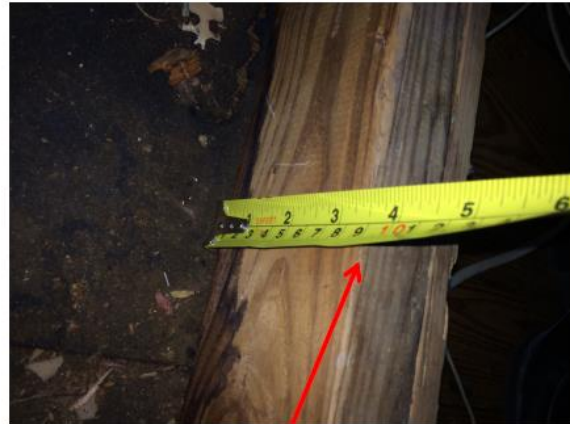
Ceiling joist 3 ½" nominal

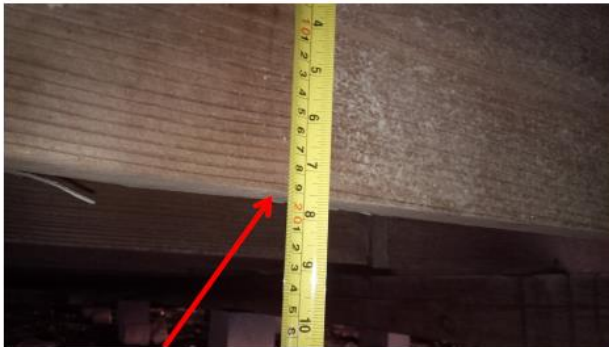
Floor joist 7 ½" nominal

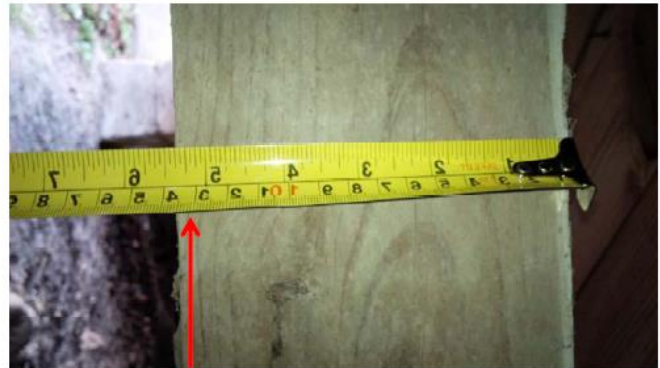
All sill beam 5 ½" x 3 ½"
